Your Inspection Report

123 Main St
Houston, TX

Tuesday, October 21, 2014

Report No. 1009

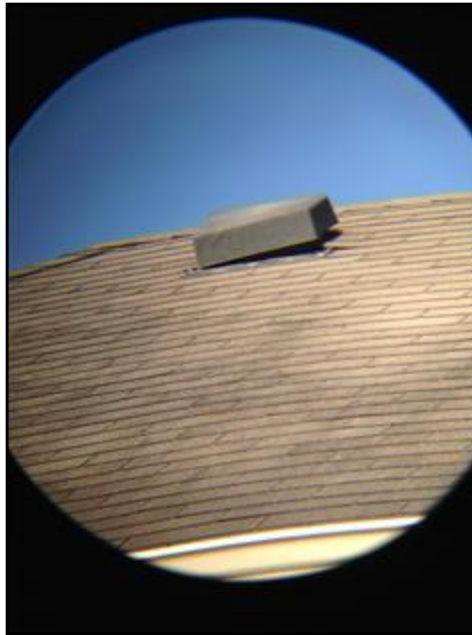
2. *Vertically misaligned*

3. **Condition:** • [Vertically misaligned](#)

Implication(s): Chance of water damage to contents, finishes and/or structure

Task: Repair

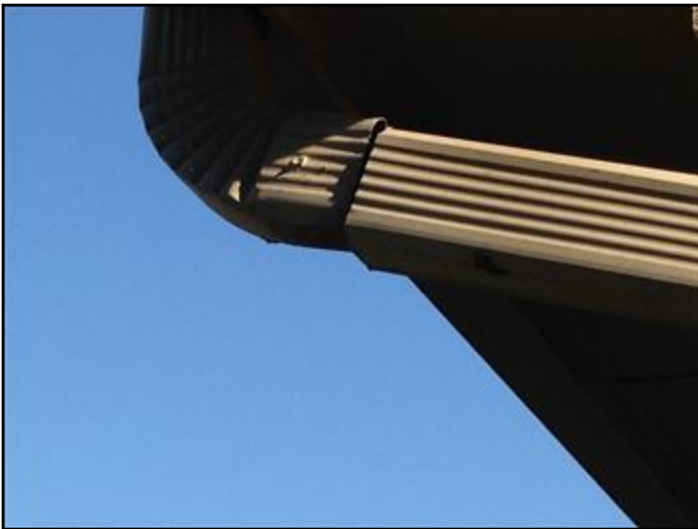
Gutter is loose by the garage

5. **Condition:** • [Loose or damaged](#)

Implication(s): Chance of water damage to contents, finishes and/or structure

7. Loose or damaged

Task: Repair

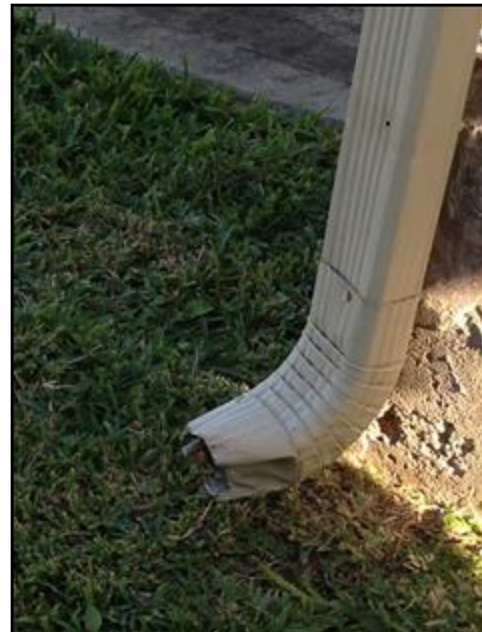
8. Loose or damaged

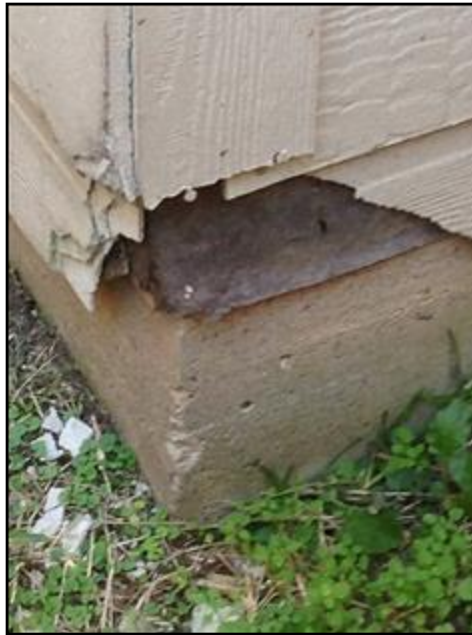
6. Condition: • [Loose or missing pieces](#)

Hardy plank is broken piece by the exterior of fireplace

Implication(s): Cosmetic defects | Chance of water damage to contents, finishes and/or structure

9. Loose or missing pieces

Task: Repair

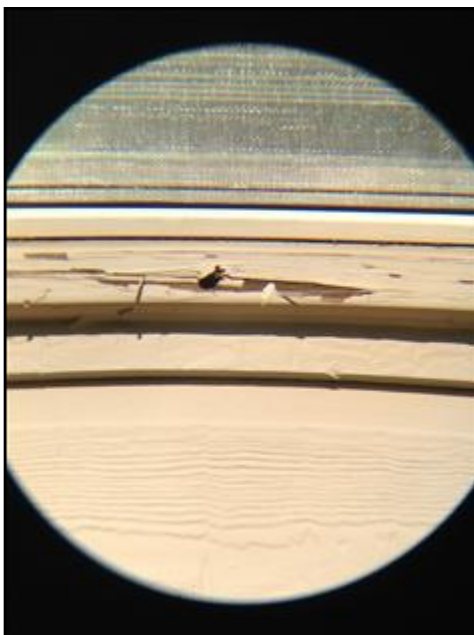
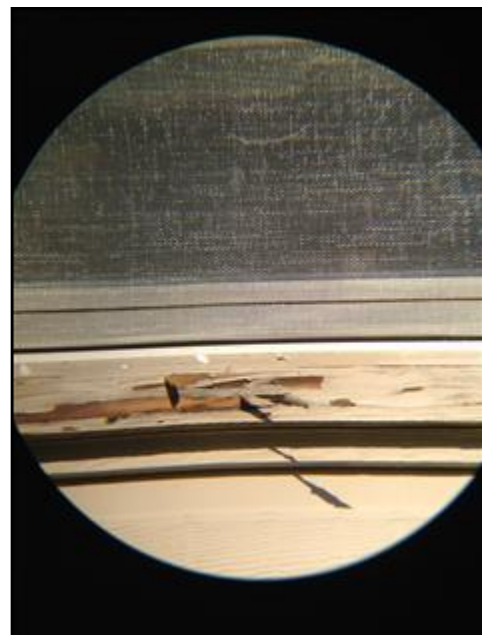
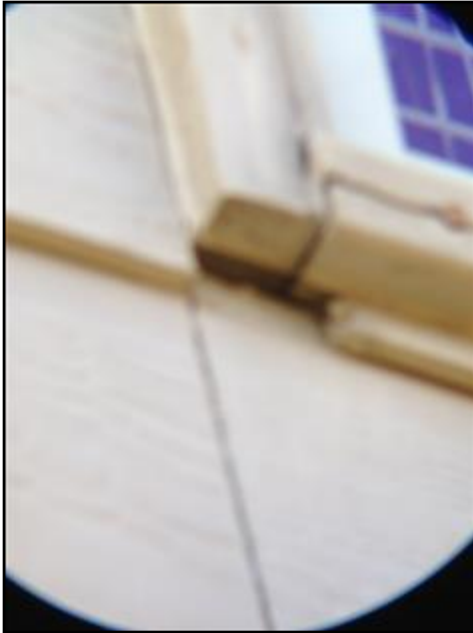
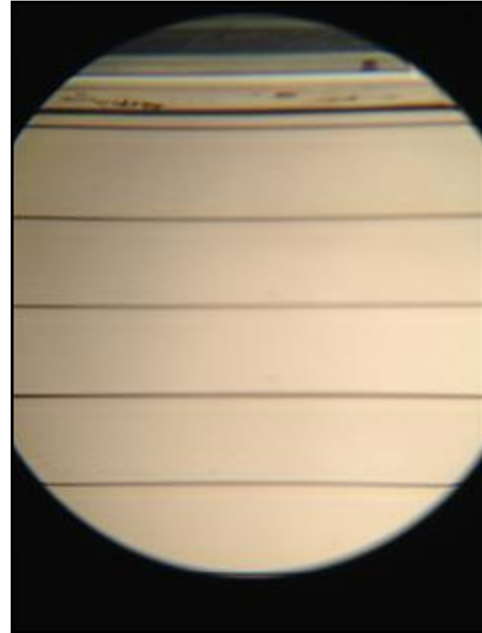
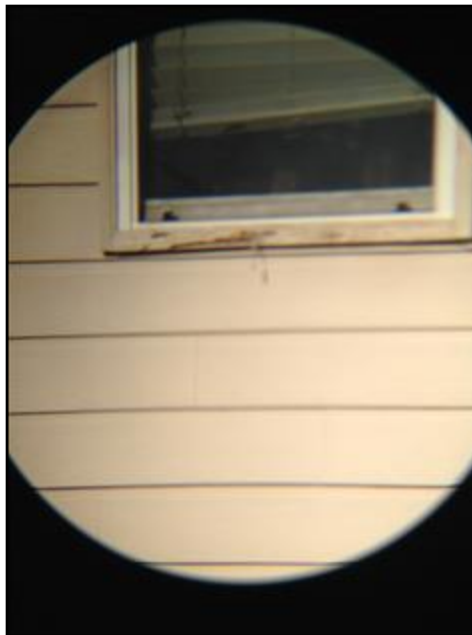
7. Condition: • [Paint or stain needed](#)

Implication(s): Chance of water damage to contents, finishes and/or structure | Material deterioration

10. Paint or stain needed

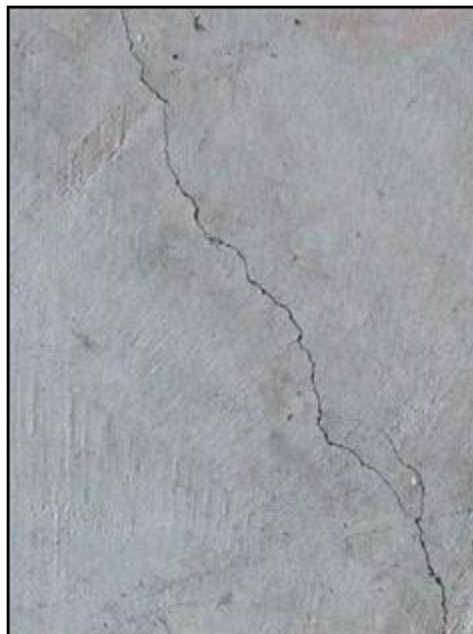
12. Condition: • Typical minor cracks

Location: Various First Floor Garage

15. Typical minor cracks

Task: Monitor

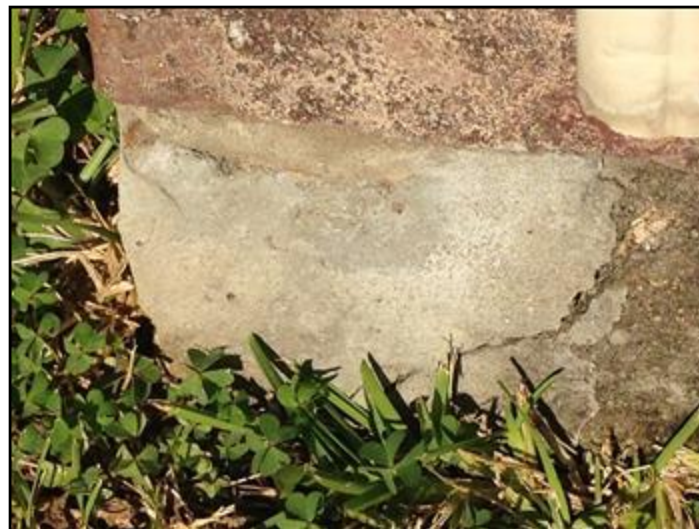
13. Condition: • [Spalling, crumbling or broken material](#)

chalking for protection, no structural damage.

16. Spalling, crumbling or broken material

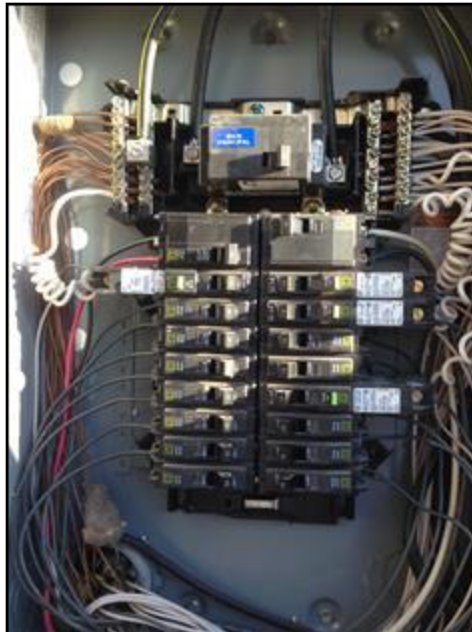
Only bed rooms AFCI, other areas also required where GFCI are not installed.

17. AFCI - bedroom

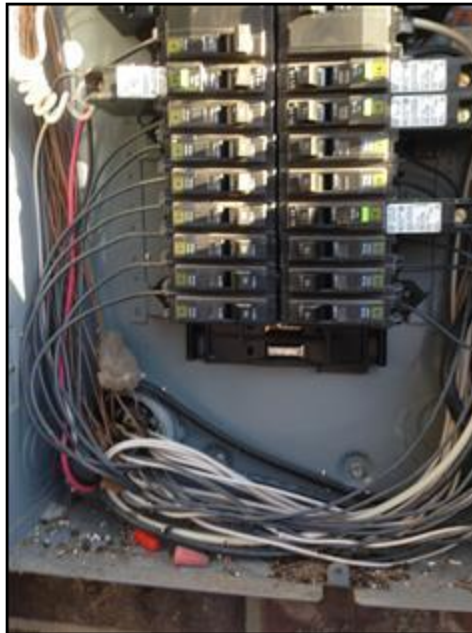
18.

14. Condition: • Main panel has evidence of mice droppings

Task: Further evaluation Improve Clean Protect

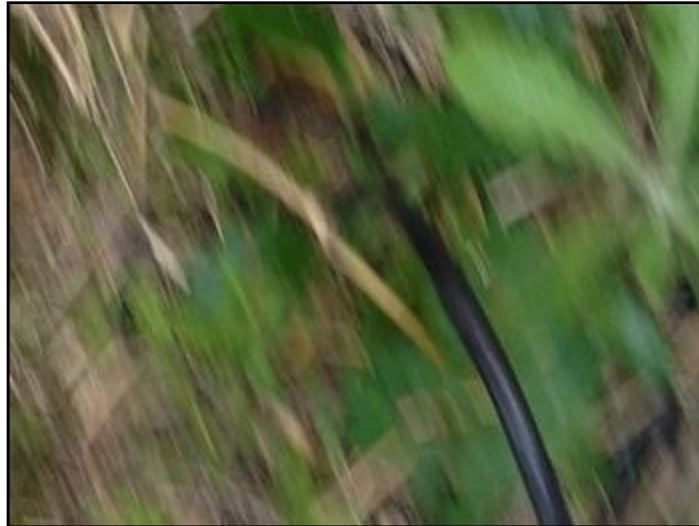
19.

16. Condition: • Ground rod buried in the ground

Task: Improve

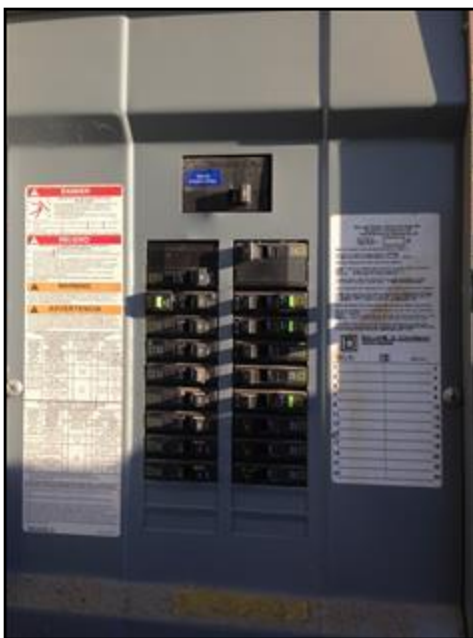
17. Condition: • [Circuits not labeled](#)

20. Circuits not labeled

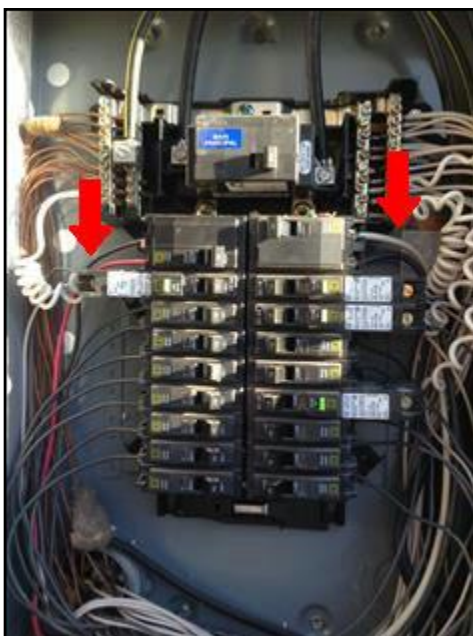
18. Condition: • [Improper color coding](#)

Implication(s): Electric shock | Fire hazard

21. Improper color coding

Task: Improve

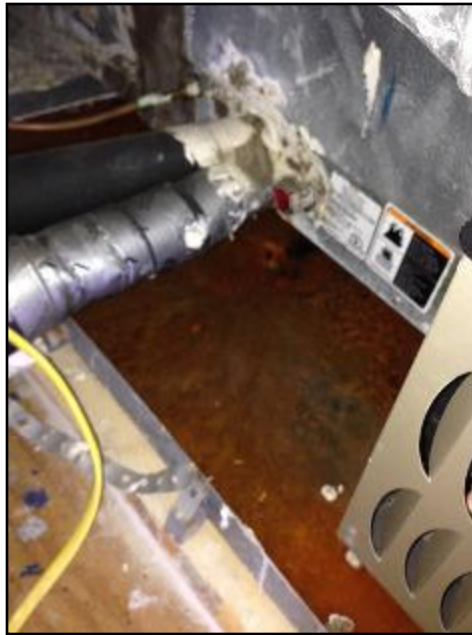
21. Condition: • [Pan overflowing](#)

Implication(s): Chance of water damage to contents, finishes and/or structure | Damage to equipment

22. Pan overflowing

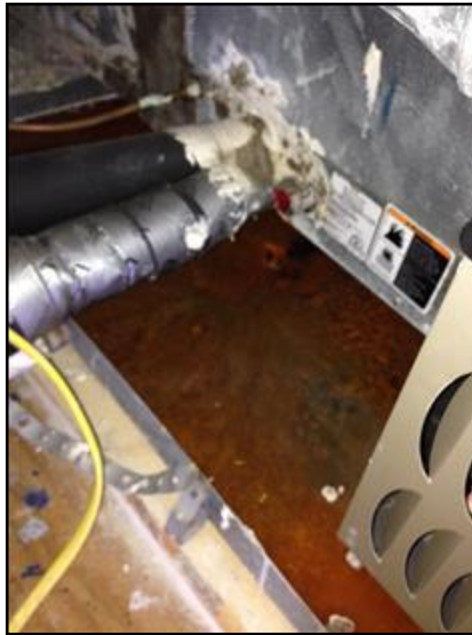
22. Condition: • [Blocked or crimped](#)

Implication(s): Chance of water damage to contents, finishes and/or structure | Damage to equipment

23. Blocked or crimped

Task: Repair Further evaluation

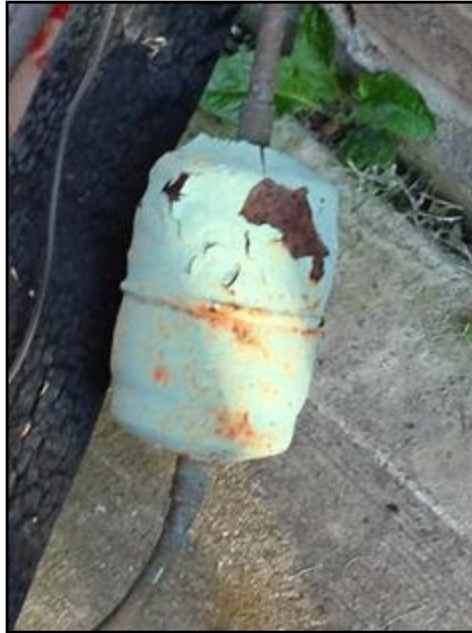
23. Condition: • [Damage](#)

Implication(s): Reduced system life expectancy | Increased cooling costs | Reduced comfort

24. Damage / rusted

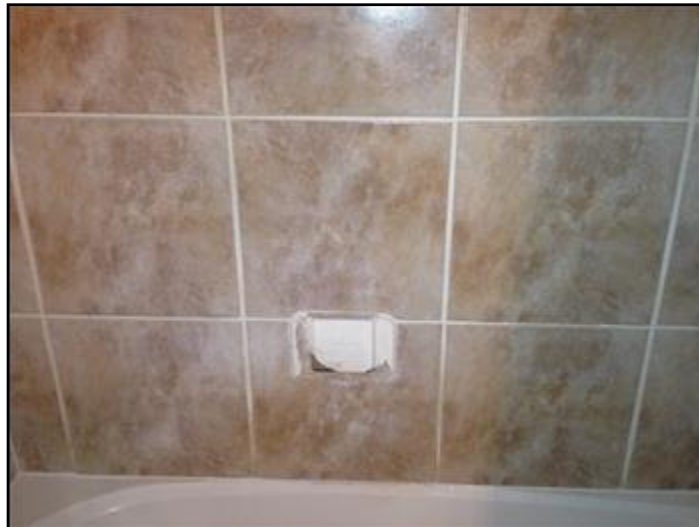
25. Condition: • [Tile loose, broken or missing tile](#)

Soap dish is missing

Implication(s): Cosmetic defects | Chance of water damage to contents, finishes and/or structure

25. Tile loose, broken or missing tile

Task: Repair

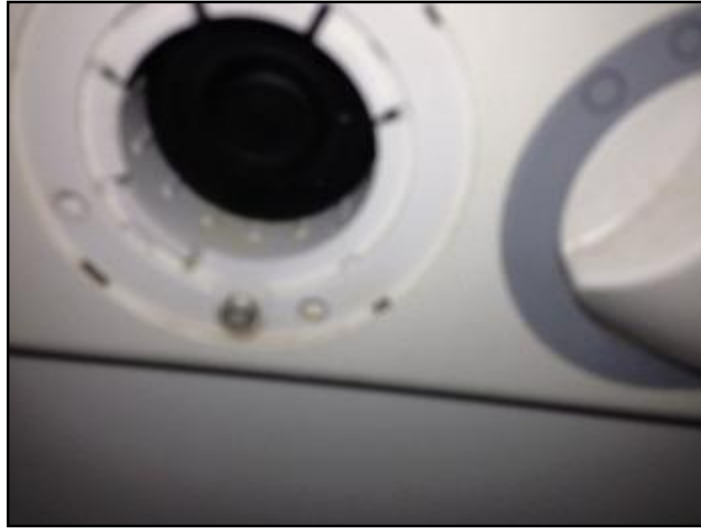
27. Condition: • [Inoperative](#)

Implication(s): Equipment failure

26. Inoperative

Task: Repair or replace Further evaluation

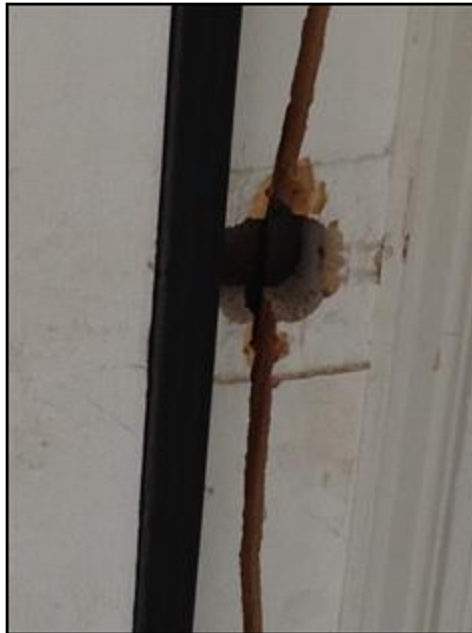
28. Condition: • [Damage](#)

Implication(s): Cosmetic defects

27. Damage

Task: Repair or replace
