Your Inspection Report

123 Main St
Houston, TX

Tuesday, October 21, 2014

Report No. 1009

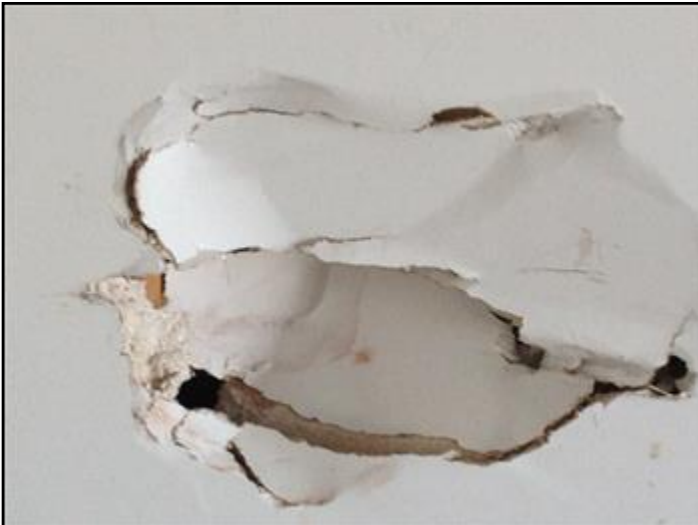
3. General

Garage walls are damage

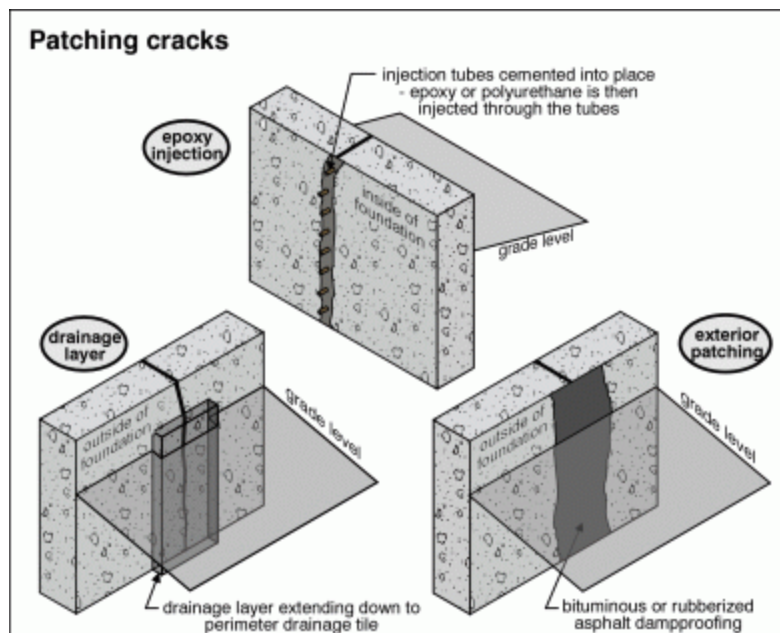
Crack repair - epoxy and polyurethane injection

epoxy is as strong as concrete and forms a structural seal

however, it hardens slowly, and if there is space at the back of the crack, it may leak out

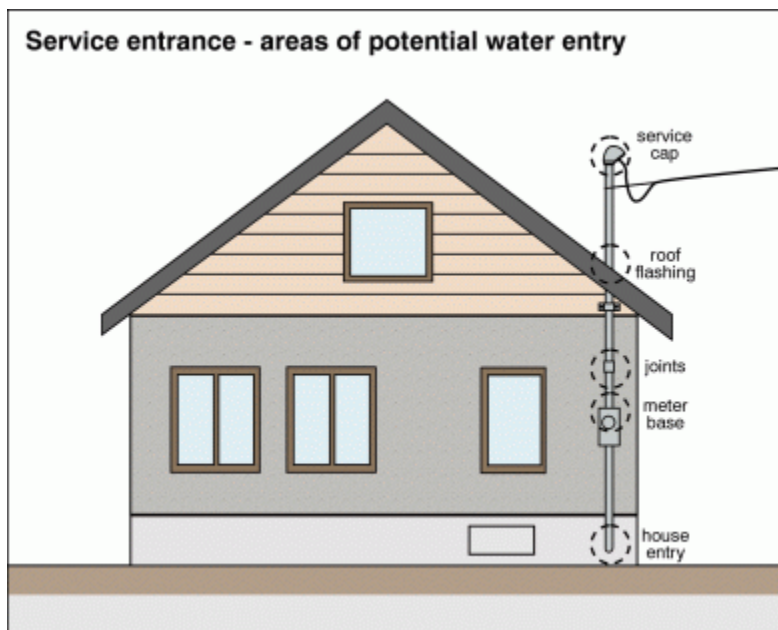
15. Condition: • [Box not weather-tight](#)

Implication(s): Shock hazard or interruption of electrical service

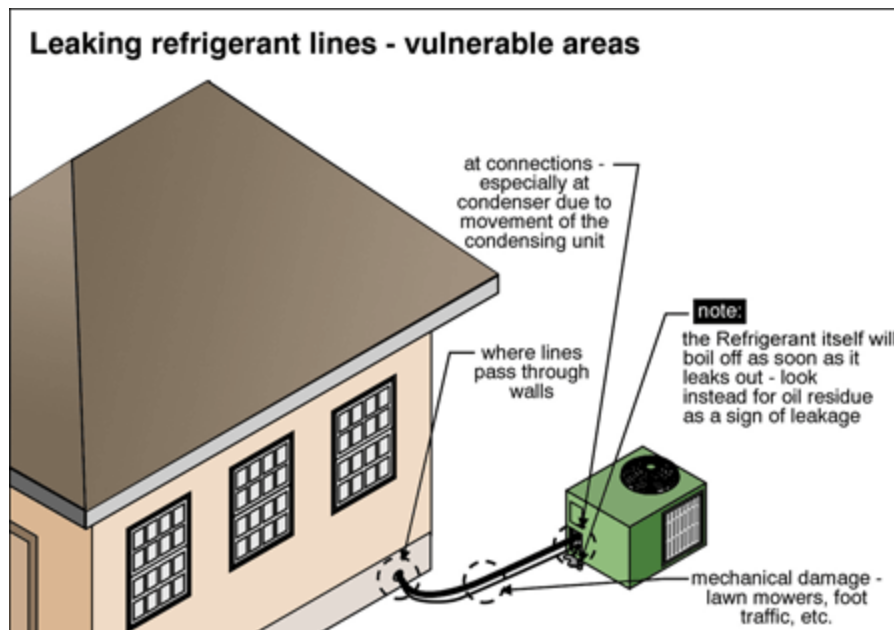
23. Condition: • [Damage](#)

Implication(s): Reduced system life expectancy | Increased cooling costs | Reduced comfort
